SAIB: CE-18-26

Date: September 4, 2018

SUBJ: Liquid Penetrant Inspection; Using Visible Dye Penetrant

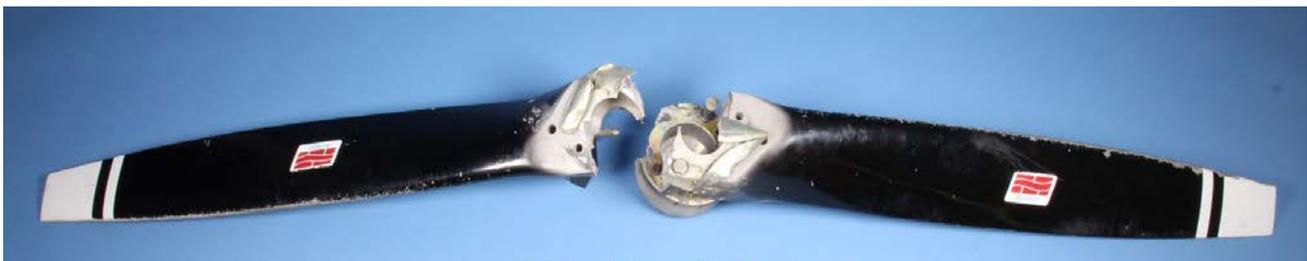
The picture below captures a propeller from an accident. As can be seen, the accident propeller was a single-piece, aluminum, fixed-pitched model. Although the airplane was destroyed, the two occupants survived with serious injuries.

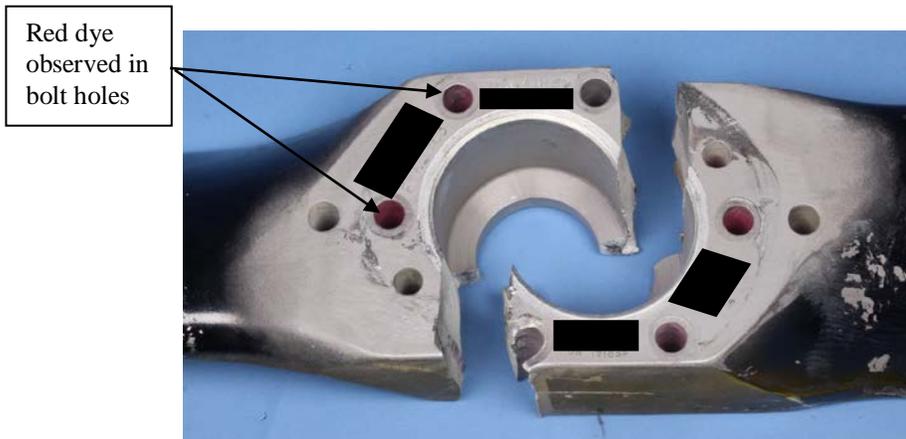
In the photograph above, you can observe residual visible red dye penetrant in some of the propeller hub holes from a prior inspection. It was concluded that post inspection cleaning after the use of red dye was not adequate and did not remove all of the red dye material. Fluorescent dye penetrant was used for the last AD inspection just prior to the propeller failure. Fluorescent penetrant inspection loses effectiveness when there is improper cleaning of red dye from a previous inspection. Visible dye material residue can be extremely difficult to remove and can fill voids, flaws, and cracks, which can affect subsequent inspections. Visible dye residue contamination of fluorescent penetrant fluid is also known to significantly reduce the brightness of fluorescent indication and can mask the fluorescent agent, causing flaws in the part to be minimized or missed at the next inspection.

Due to these characteristics, visible dye penetrants can make existing cracks nearly impossible to detect when using fluorescent penetrant inspection for the next inspection. Pre- and post-inspection cleaning is critical to ensure the ability to detect cracks during current and follow-on inspections and is essential to ensure proper detection of the anomalies and cracks in the article. Inspection material residuals can also lead to corrosion.

- Be aware of the risks associated with using visible dye penetrant inspection methods.
- Per FAA policy, do not use visible dye penetrant using ordinary white light for the inspection of safety critical engine, propeller, or APU hardware. (Ref. Policy Memo PS-ANE100-2000-00010).

- Review the information in any AD requiring “dye penetrant” or “liquid penetrant” inspection of any safety critical part and follow the AD instructions, and/or the design approval holders (DAH) Instructions for Continued Airworthiness (ICA) with respect to inspection methods, materials, and techniques. Contact the DAH for assistance with their approved inspection methods. However, it should be noted that if there are any discrepancies between any AD and the DAH ICA’s, the AD takes precedence without an alternative method of compliance from the FAA office that issued the AD.

- Adhere to the prohibition contained in American Society for Testing and Materials (ASTM E 1471), which prohibits the use of Type II visible dye penetrant prior to the use of Type I fluorescent penetrants for the same surface.

- Adhere to the DAH pre- and post-inspection cleaning methods and materials to ensure any residual developer, penetrant, and/or visible dye residues are removed which could affect subsequent inspections.
