NAVIGATION - STALL WARNING HORN REPLACEMENT

MODEL	SERIAL NUMBERS
182S	18280001 thru 18280944
182T	18280945 thru 18282449, 18282451 thru 18283115
T182T	T18208001 thru T18209100
206H	20608001 thru 20608353
T206H	T20608001 thru T20609250, T20609252 thru T20609616

SEB-34-22
Page 1 of 10

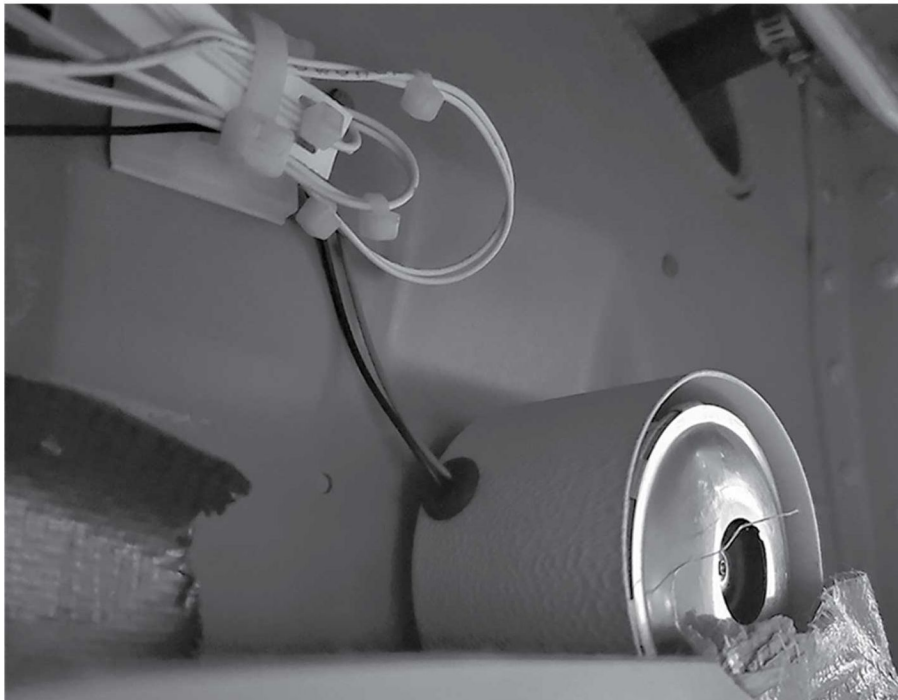
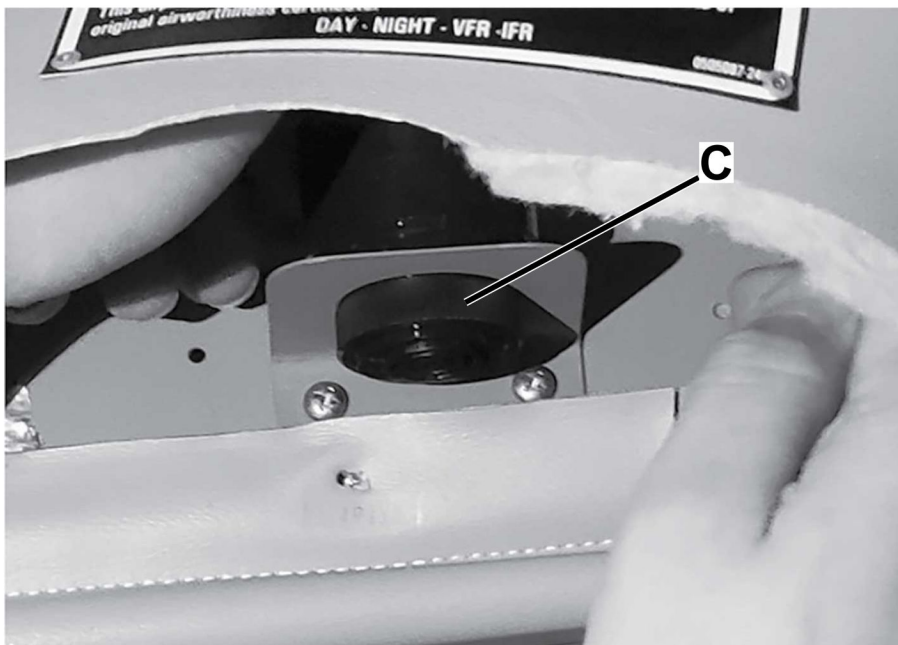
Figure 1. Warning Horn Modification (Sheet 2)

Before Modification, Old Horn

After Modification, New Horn

8. (Refer to Figure 1, Sheets 1 thru 3.) Install the SC648NDR Horn as follows:

- B. Put the SC648NDR Horn into the 0718032-1 Bracket.

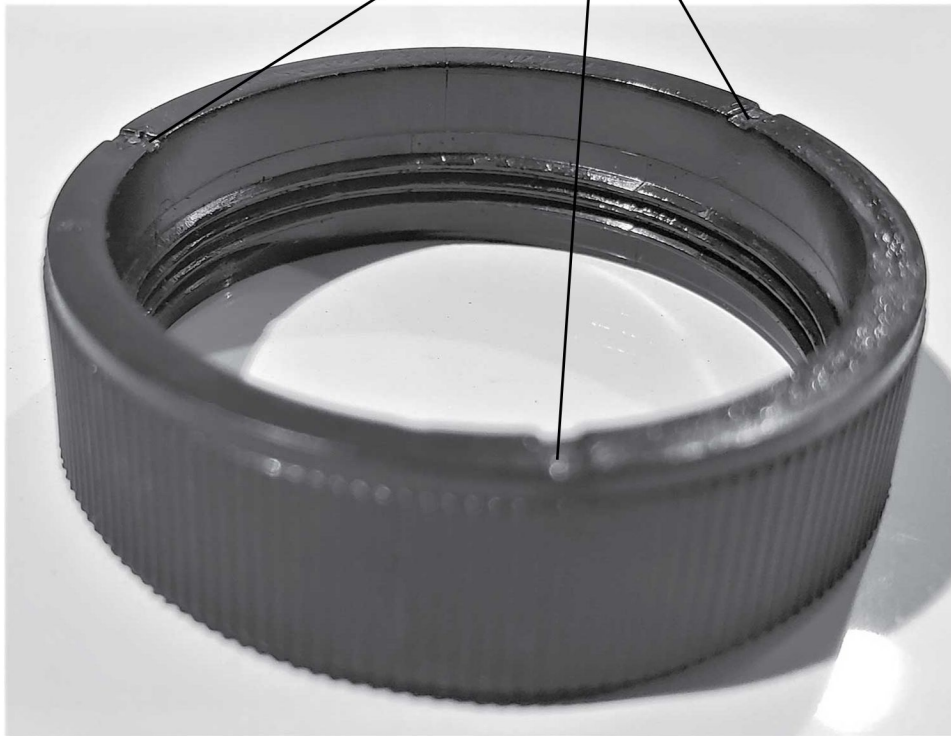
Figure 1. Warning Horn Modification (Sheet 3)

Install with three detents first.
Detents go toward bracket and horn.

Knurled Nut Install Direction

NOTE: (Refer to Figure 1, Sheet 3.) The plastic knurled nut must be installed with the three indents toward the bracket and horn assembly. On the internal circumference, the smooth side without threads is installed first, towards the bracket and horn. This technique of installation will make sure the nut fully seats against the bracket and not bottom-out on the threads. If not installed correctly the knurled nut will bottom-out on the threads and the horn assembly will not be fully tightened in the bracket.
