# multi-engine SERVICE LETTER

ME72-26

SUBJECT: FRONT WING SPAR INSPECTION

AIRCRAFT AFFECTED: All Model 336 and 337 Series with more than 3000 Hours  
Time In-Service on the Airframe

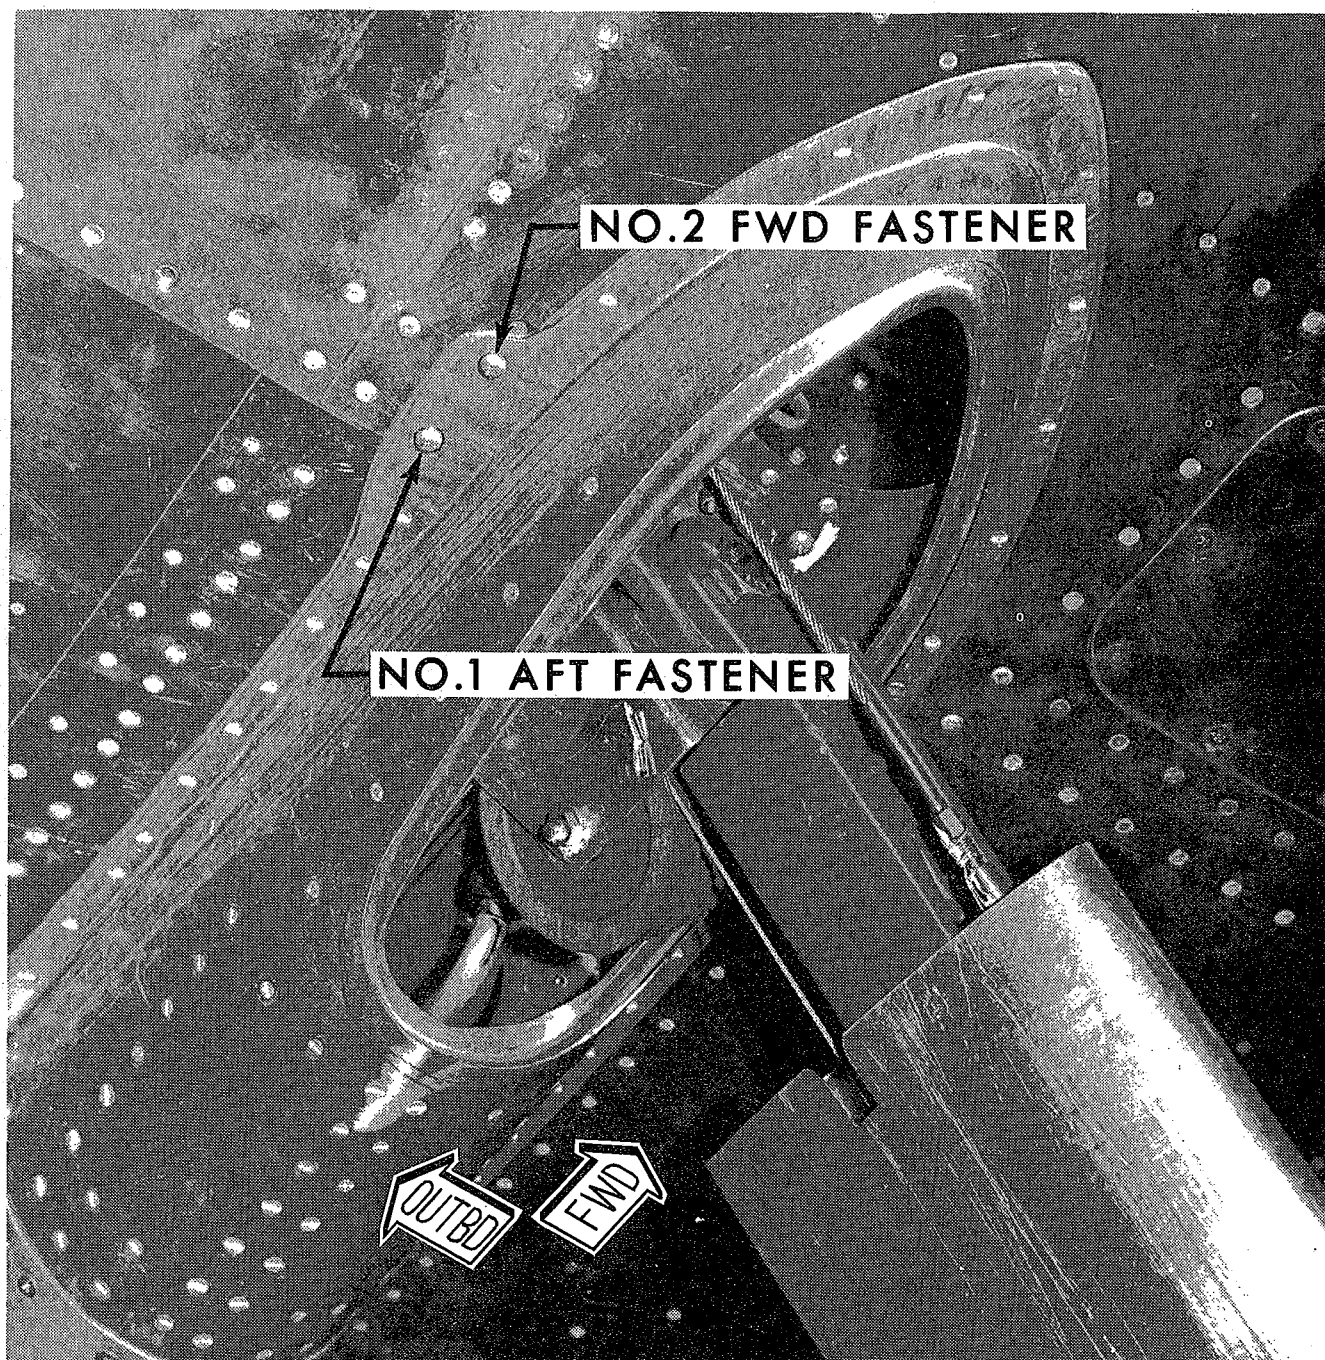
**Fig. 1**

The area to be inspected is immediately outboard of the wing-strut attachment. Figure 1 shows this area and two fasteners (NAS 221 screws located at Wing Station 64.41) that must be removed for the inspection. These screws secure the outboard edge of the boom, the lower wing skins, a doubler plate, the horizontal flanges of the lower spar cap and angles on top of the lower spar cap. A cross section with the screws removed is shown in Figure 2.

**WING STRUT ATTACHMENT AREA  
WITH STRUT CUFF REMOVED**

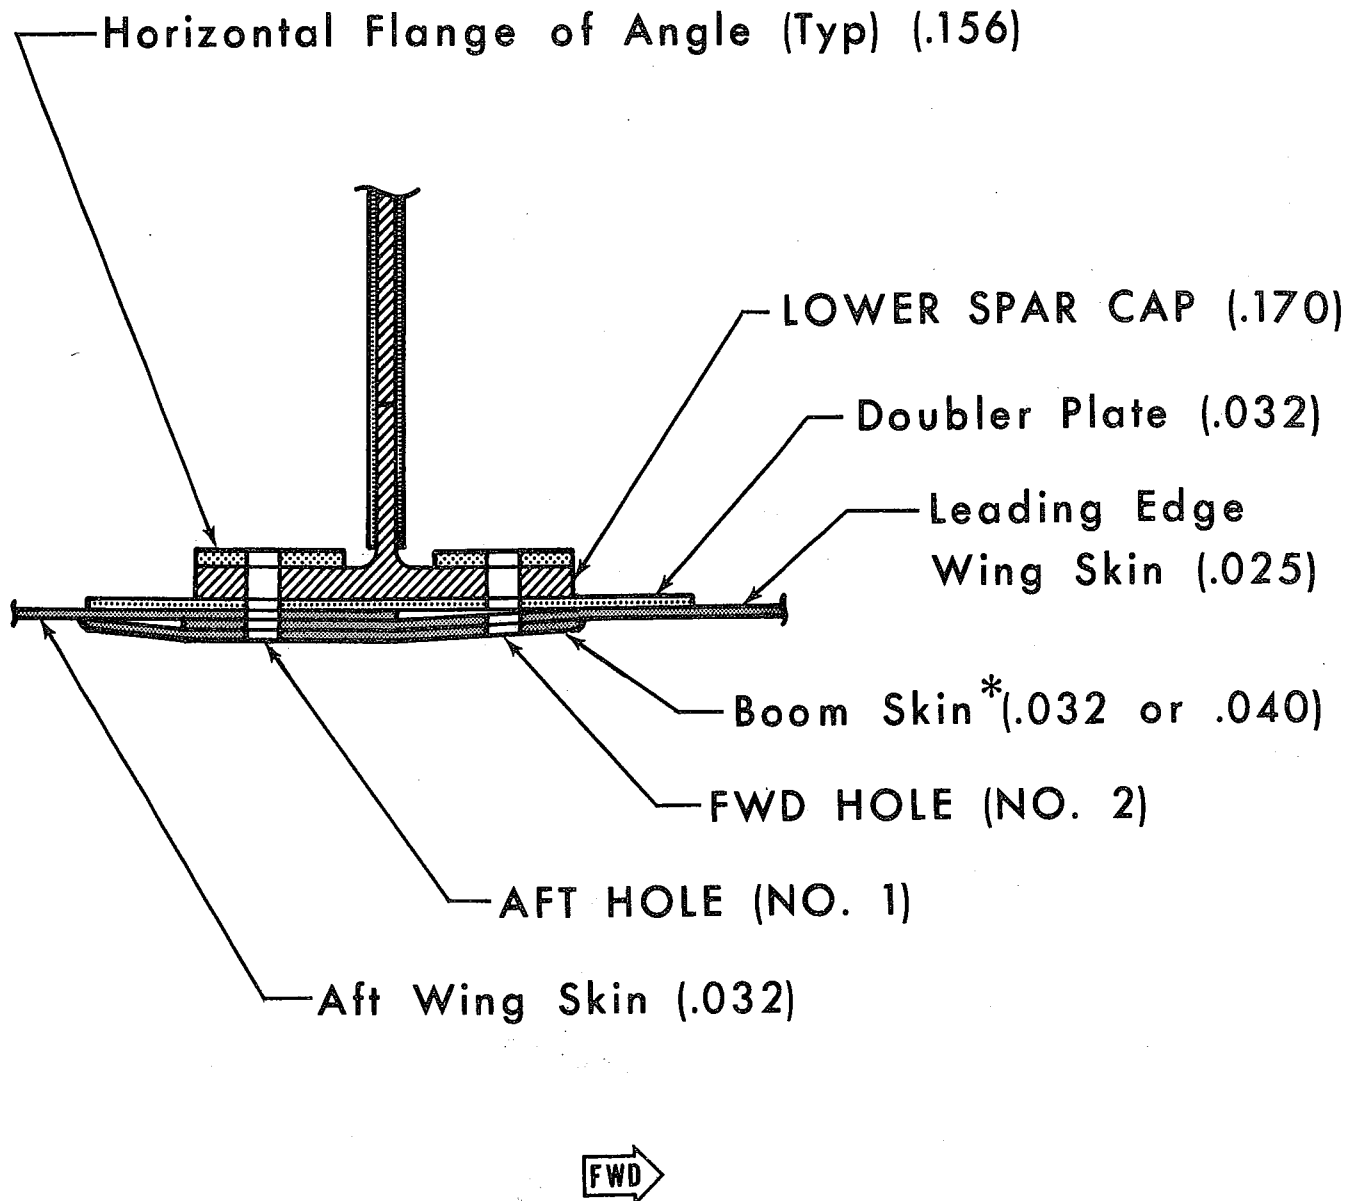
Fig. 2

# LOWER SPAR CAP AT FASTENERS

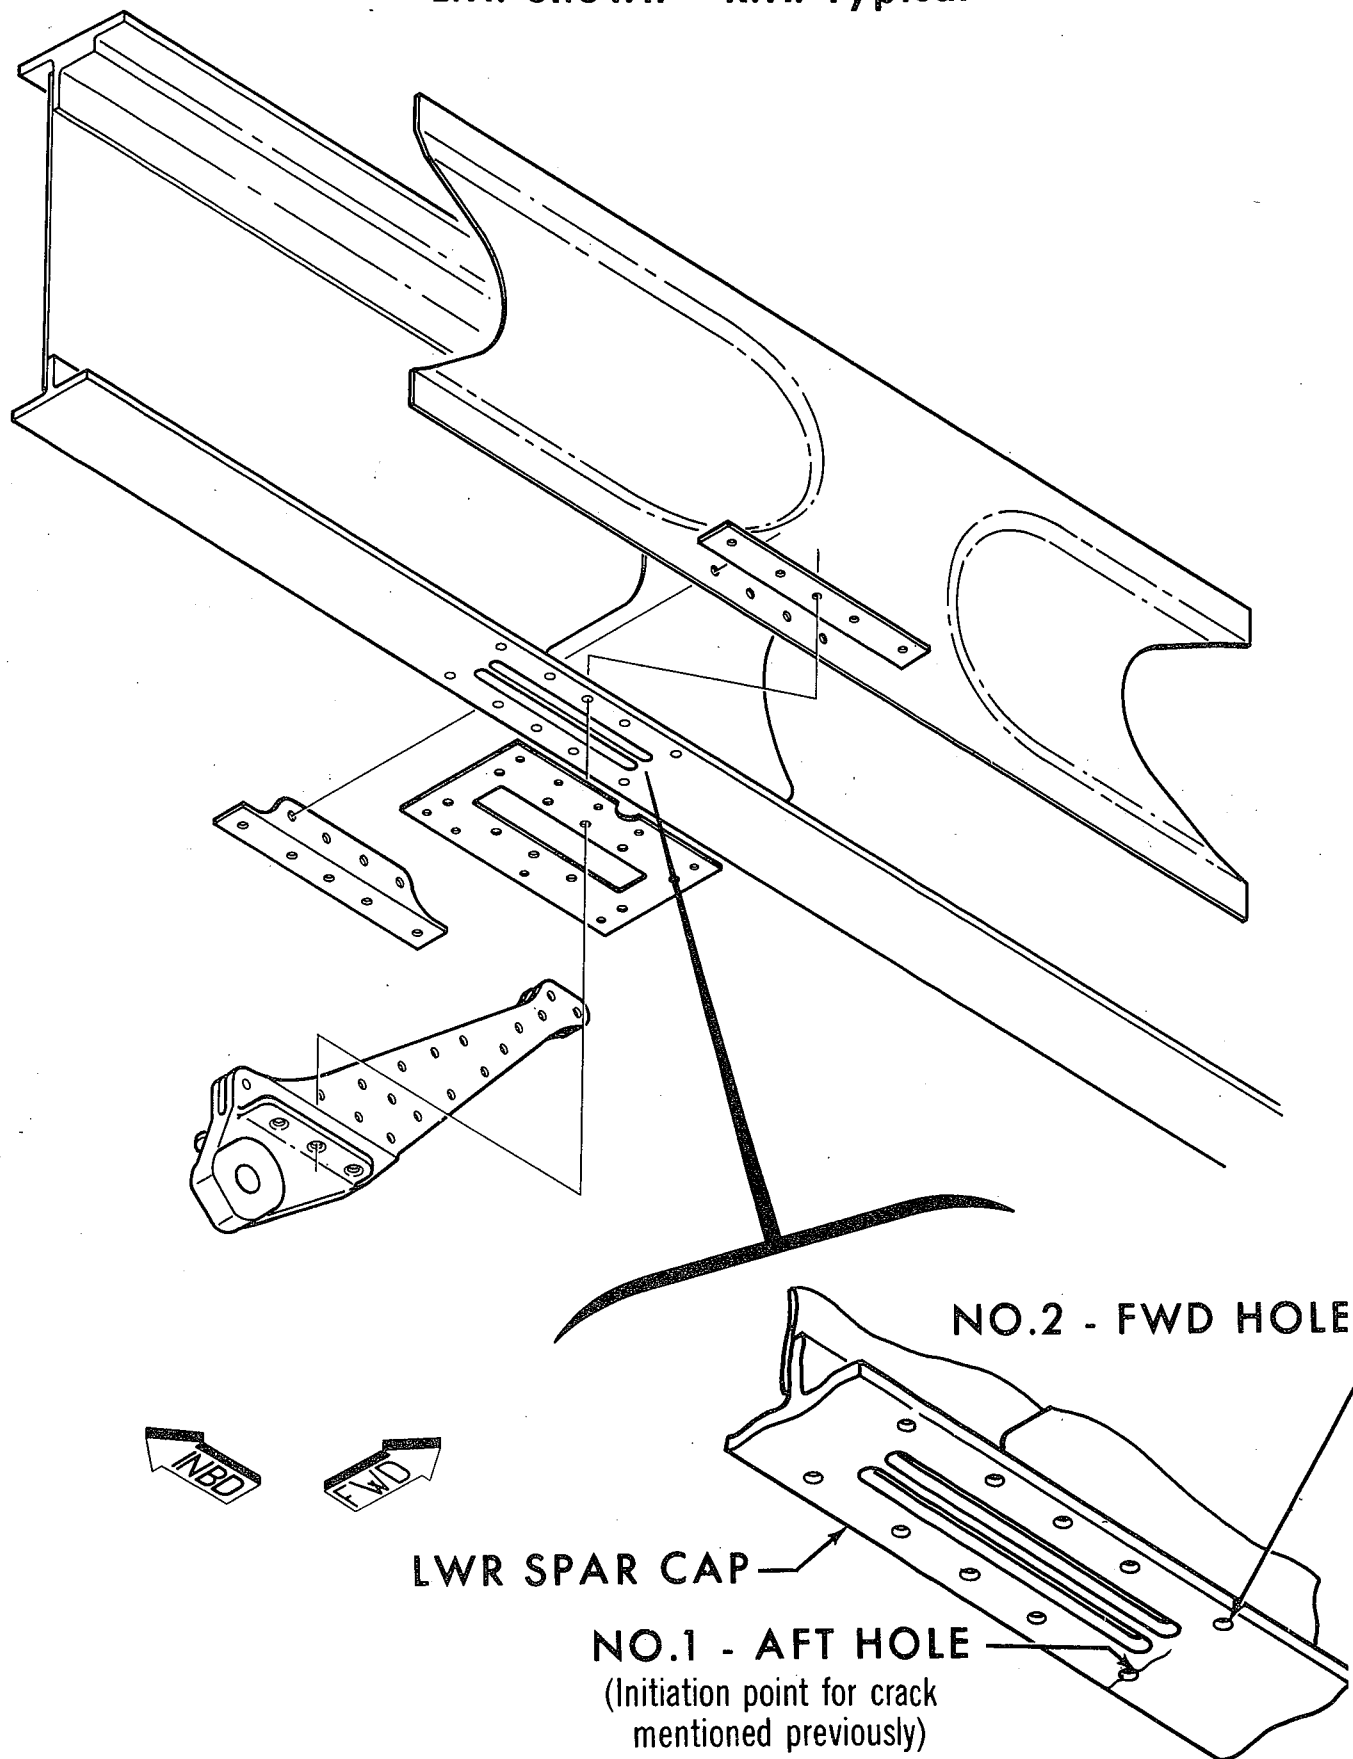
Fig. 3

As a result of inspection of these aircraft, it was found that a fatigue crack had started in a bolt hole in the lower cap of the front wing spar at the strut attach point on both aircraft.

The lower spar cap is a T-section and the material is 2014-T6 or 2014-T6511, depending on the year the aircraft was manufactured. An exploded view of the spar assembly (less boom and wing skins) shows the relationship of the lower cap to the other parts at the strut attachment in Figure 3. Also shown in this figure is the initiation point for the abovementioned crack.

If a crack is found, the lower spar caps in both wings must be replaced prior to further operation.
